DEPARTMENT OF TRANSPORTATION**DIVISION OF ENGINEERING SERVICES**

Contract #: 04-0120F4Cty: SF/ALA Rte: 80 PM: 13.2/13.9File #: 69.28**WELDING INSPECTION REPORT****Resident Engineer:**Siegenthaler, Peter**Address:** 333 Burma Road**City:** Oakland, CA 94607**Report No:** WIR-023717**Date Inspected:** 17-May-2011**Project Name:** SAS Superstructure**OSM Arrival Time:** 700**Prime Contractor:** American Bridge/Fluor Enterprises, a JV**OSM Departure Time:** 1900**Contractor:** Zhenhua Port Machinery Company, Ltd (ZPMC), Changxing Island **Location:** Shanghai, China**CWI Name:** Zhu Zhong Hai**CWI Present:** Yes No**Inspected CWI report:** Yes No N/A**Rod Oven in Use:** Yes No N/A**Electrode to specification:** Yes No N/A**Weld Procedures Followed:** Yes No N/A**Qualified Welders:** Yes No N/A**Verified Joint Fit-up:** Yes No N/A**Approved Drawings:** Yes No N/A**Approved WPS:** Yes No N/A**Delayed / Cancelled:** Yes No N/A**Bridge No:** 34-0006**Component:** Orthotropic Box Girder(OBG)**Summary of Items Observed:**

OBG # TRIAL ASSEMBLY YARD**WELDING:****Segment 13AW**

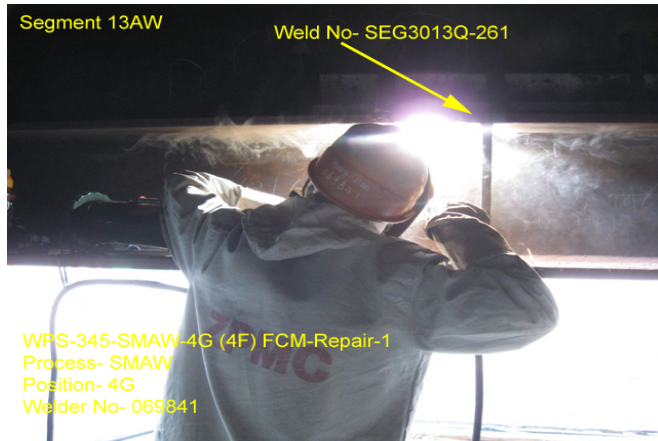
This QA Inspector observed ZPMC qualified welding personnel identified as 069841 perform Shielded Metal Arc Welding (SMAW), weld joint identified as SEG3013Q-261 ; located On Orthotropic Box Girder (OBG) FL3 to Stiffener CJP Weld; ZPMC Quality Control (QC) is identified as Mr. Zhang Lin. This QA Inspector observed the base material appears to have been preheated by an electrical heating element prior to welding. The Welding Repair Report (CWRR) was B-CWR2962. ZPMC Quality Control (QC) Mr. Zhang Lin was onsite monitoring the welding variables. The welding variables recorded by QC appeared to comply with applicable WPS-345-SMAW-4G (4F) FCM-Repair-1. See attached photo for further details.

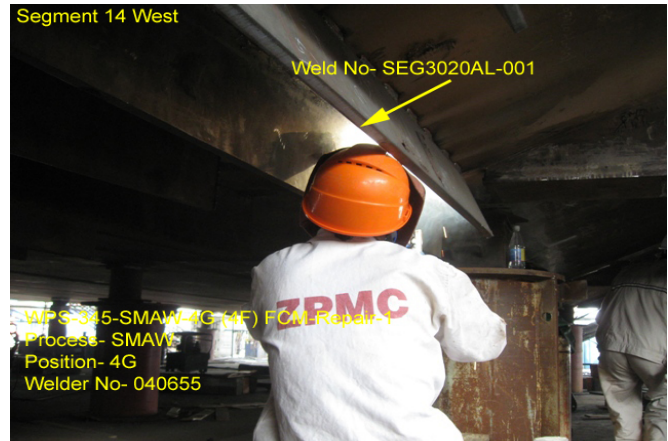
Segment 14 West

This QA Inspector observed ZPMC qualified welding personnel identified as 040655 perform Shielded Metal Arc

Welding (SMAW), weld joint identified as SEG3020AL-001; located On Orthotropic Box Girder (OBG) Deck Plate to Deck Plate CJP Weld; ZPMC Quality Control (QC) is identified as Mr. Wang Zhu. This QA Inspector observed the base material appears to have been preheated by an electrical heating element prior to welding. The Welding Repair Report (WRR) was B-WR20681. ZPMC Quality Control (QC) Mr. Wang Zhu was onsite monitoring the welding variables. The welding variables recorded by QC appeared to comply with applicable WPS-345-SMAW 4G (4F) FCM-Repair-1. See attached photo for further details.
